Inspection Date(s):	November 21, 2022	1				
Time:	Entry: 1:30		Exit: 2:30			
Media:	Water					
Regulatory Program(s)	Clean Water Act NPDES					
Company Name:	Kohanaiki Community Association					
Facility or Site Name:	Kohanaiki Community Association					
Site Physical Location:	Alahou Kohanaiki Kailua Kona, Hi 96745.					
Geographic Coordinates:						
Mailing address:	Alahou Kohanaiki K	ailua Kona, Hi S	96745.			
Facility/Site Contact:	Bill Boswell			ector, civil operations		
	Phone: 808-896-63	01	Email : b	boswell@kohanaiki.com		
Facility/Site Identifier:	Unpermitted privat	te wastewater t	reatment	plant		
NAICS:						
SIC:	4952					
Facility/Site Personnel Par	ticipating in Inspecti	on:				
Name	Affiliation	Title		Email		
Damein Souza	KCA	Director Engir	neering	dsouza@kohanaiki.com		
Jayson Pearson	Aqua Engineers	Lead Operato	r	jpearson@aquaengineers.co m		
Steve Aslenai	Aqua Engineers	Operator				
Nancy Burns, PE	Consultant			Nebpellc1@gmail.com

The purpose of the inspection was to evaluate a complaint received by EPA of potential non-compliance with regard to the operation of the private wastewater treatment system.

II.1 Facility Description

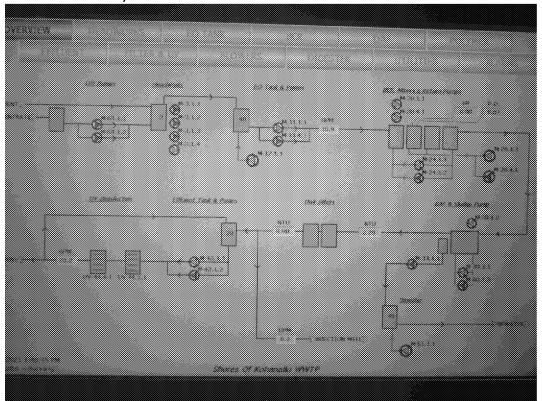
Photo 2: SCADA system overview

Facility is staffed 7 days/week. Facility has SCADA remote operations with multiple call out alarms for high flow, pump malfunction, blower malfunction.

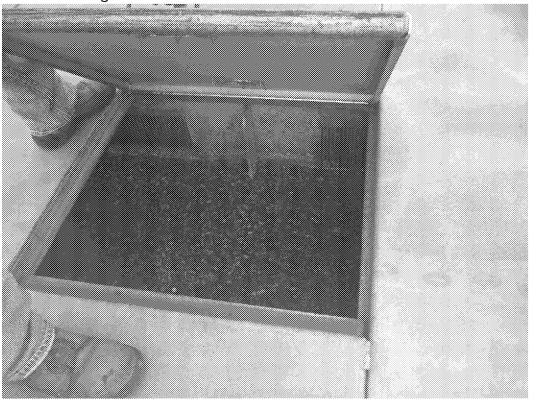
Photo 4: moving bed biofilm reactor

Treatment consists of bar screens, fine bubble aeration, moving bed biofilm reactor (MBBR), aeration, fine bubble dissolved air flotation (DAF), fine filtration and Ultra Violet (UV) disinfection. No chlorine is added.

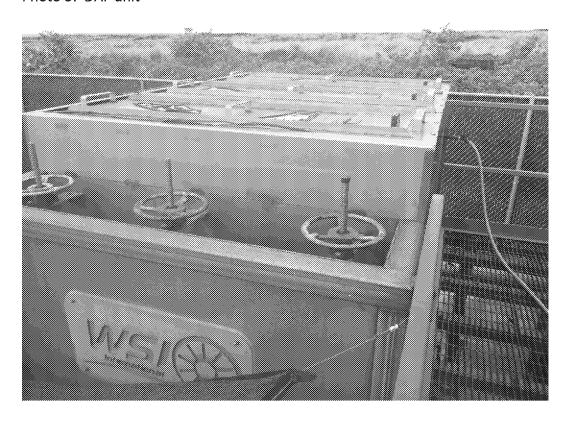
Photo 5: DAF unit

Operators stated DAF system typically achieves 4 NTU turbidity which is reduced to 1 NTU after filtration prior to the UV.
